TSMD Campbell Field Activity Trip Report Week of June 7-11, 2021

Report Preparer: Todd Campbell, RPM, Region 7 SEMD/LMSE/MSRS

TSMD TRIP REPORT PHOTOLOG

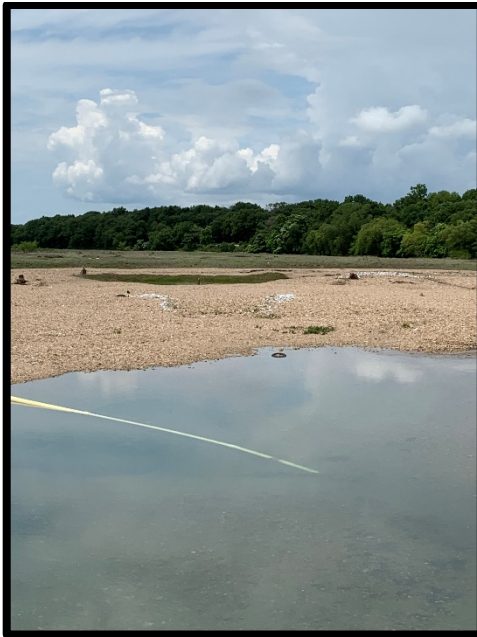
| DESCRIPTION: | Short Creek Pilot Study area – pilot test sediment trap full (IMG – 0892.jpg) |

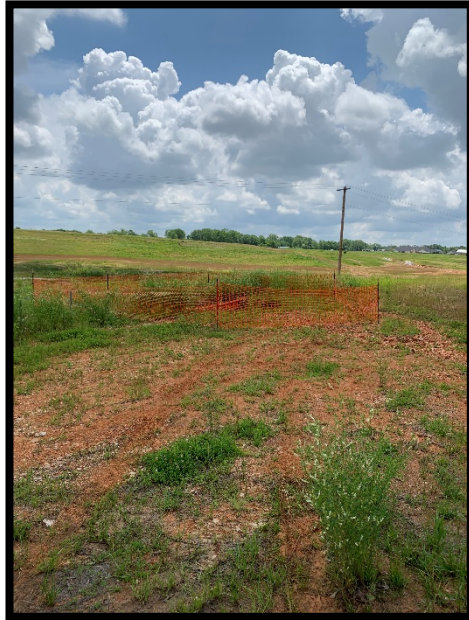
| DESCRIPTION: | Collapsed shaft at Wald/snowball mine with installed warning fencing (IMG 0893.jpg) |

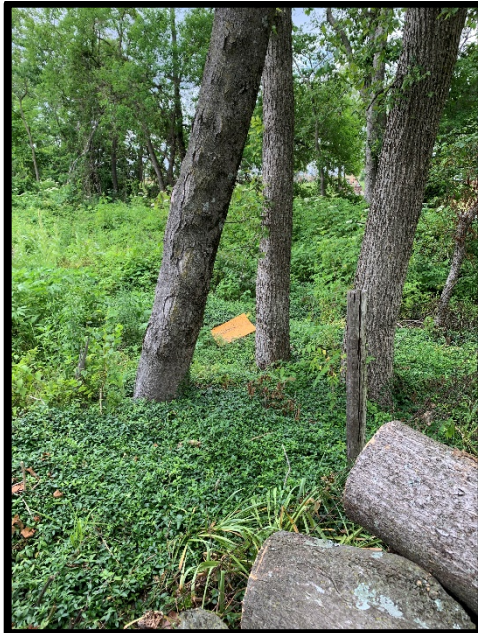
| DESCRIPTION: | Leaning trees at Fortner Property (IMG 894.jpg) |

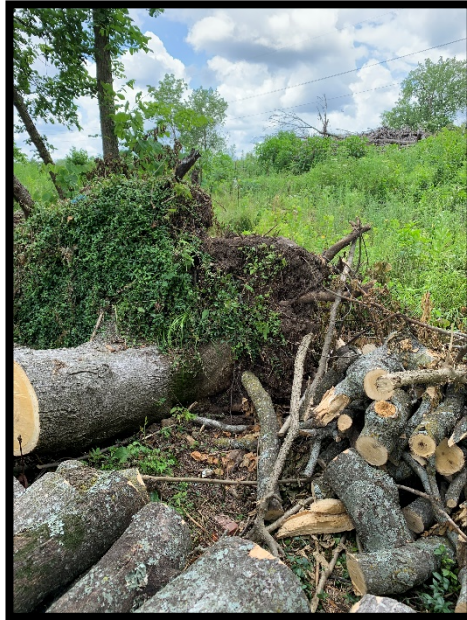
| DESCRIPTION: | Stump of tree that fell during last storm on May 27, 2021 (IMG-0895.jpg) |

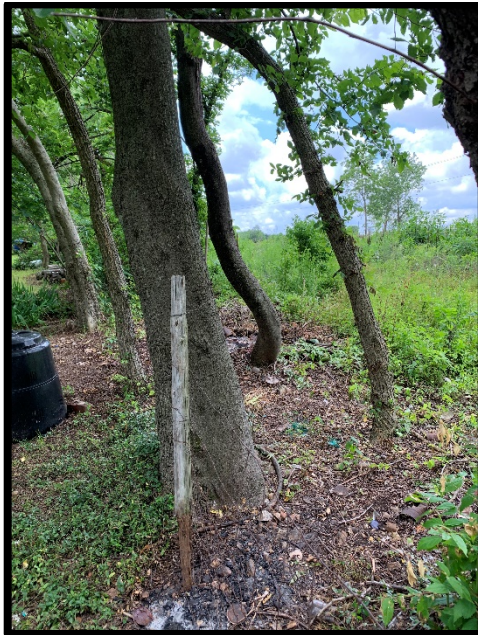
| DESCRIPTION: | More leaning trees at Fortner Property (IMG 0896.jpg) |

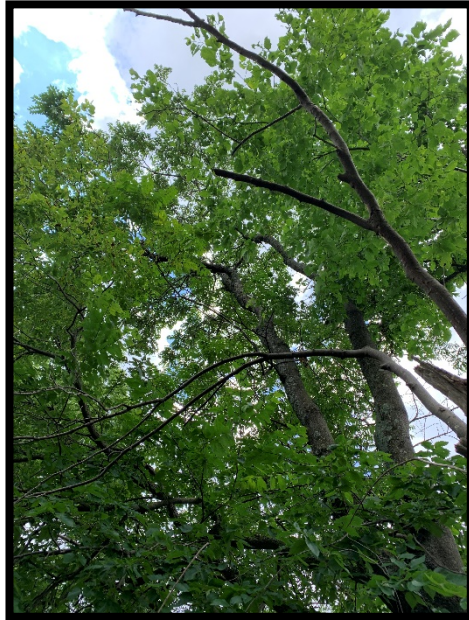
| DESCRIPTION: | Top of tree near home that is leaning along with dead limbs (IMG 0897.jpg) |

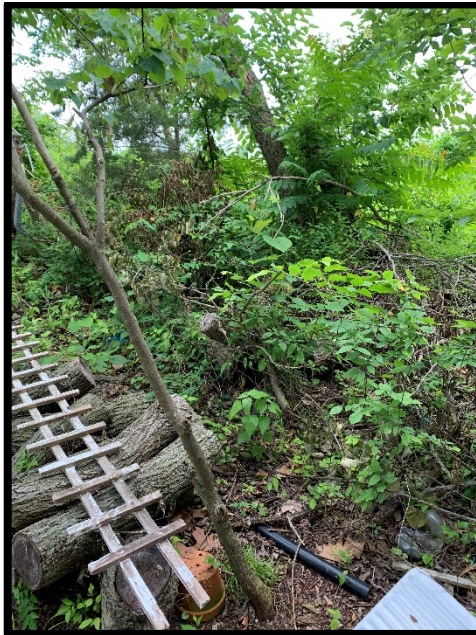
| DESCRIPTION: | Leaning tree at Fortner Property (IMG 0898.jpg) |
